| Engine Cooling | Water pump | Warranty diagnosis tool | Information

Water pump diagnosis module

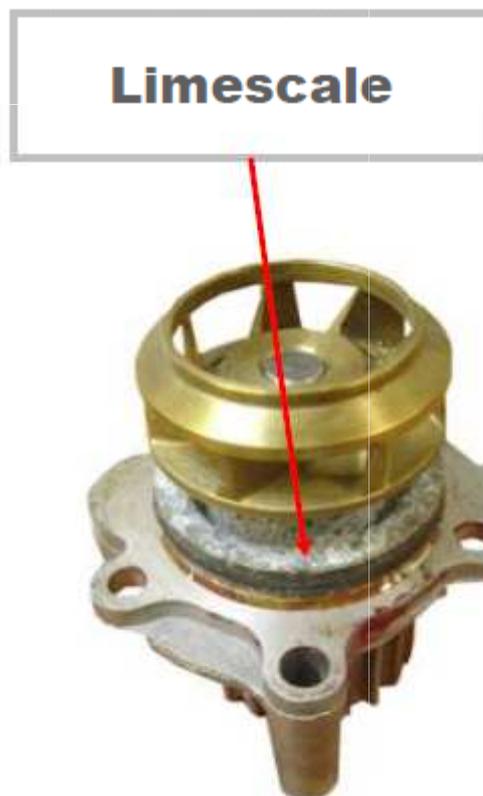
1.1 Limestone's presence

Defect description: leakage on the water pump

Diagnosis: limestone's presence on the body of the water pump

Potential cause: Use of tap water containing lime, which scratches the surfaces of the mechanical seal.

Only use the correct coolant fluid containing corrosion inhibitor recommended by car manufacturer.

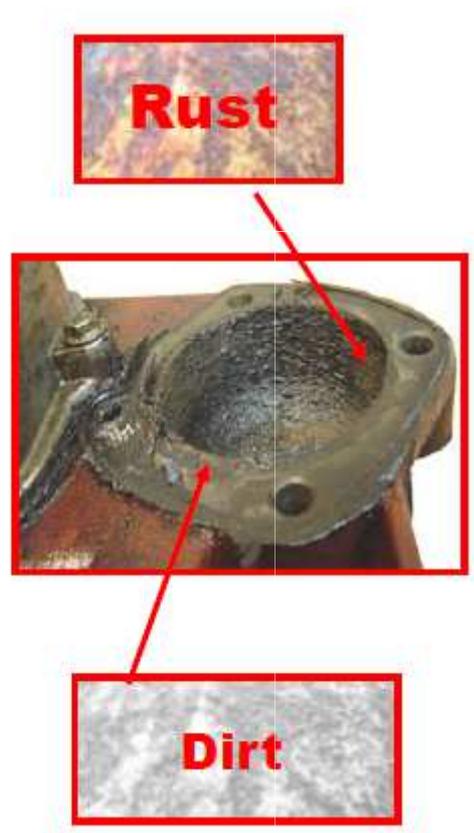
1.2 Presence of rust

Defect description: leakage on the water pump

Diagnosis: presence of rust on contact surface between engine and water pump

Potential cause: Damaged mechanical seal due to:

- Dirtiness trapped between the seal faces.
- Incorrect cleaning of the system.
- Bad coolant liquid.

Before fitting a new water pump, please carry out the following:

-Thoroughly flush the cooling system, including radiator and hoses etc otherwise when the pump starts working the coolant may move dirt through the cooling system, causing pump failure.

-Change the coolant fluid.

-Clean engine contact surface

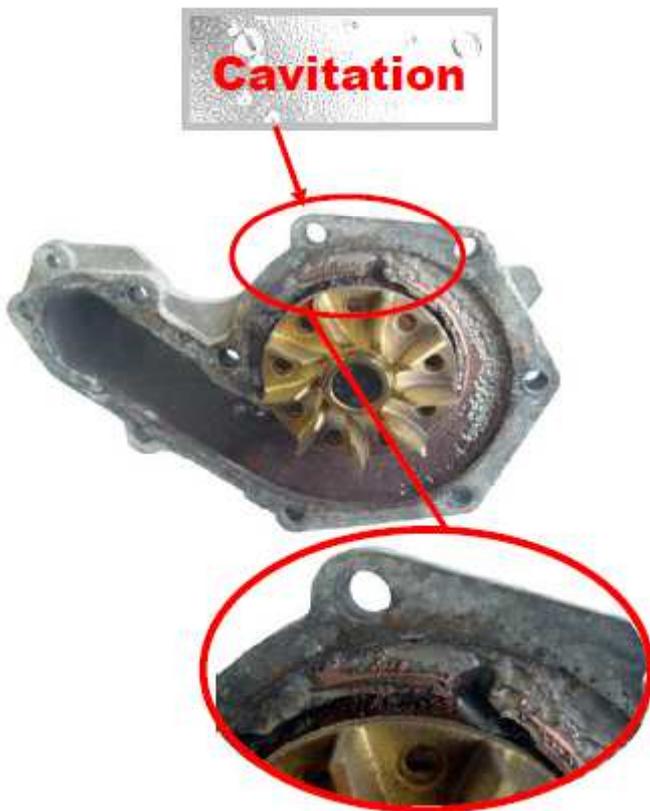
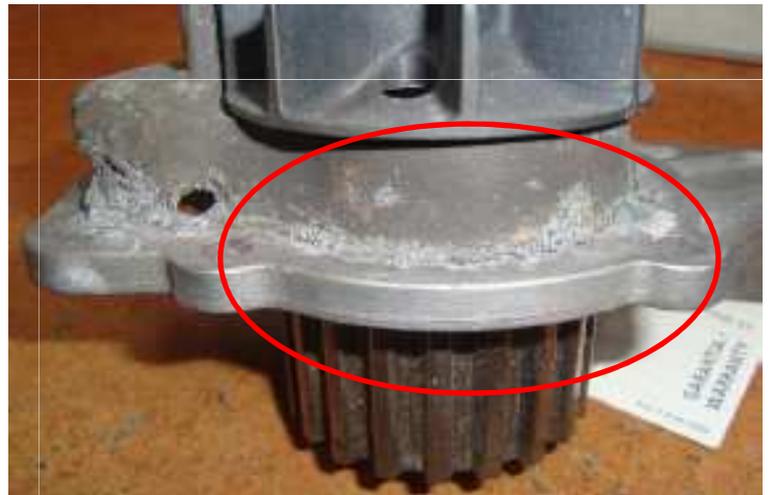
1.3 Coolant liquid overheated

Defect description: leakage on the water pump

Diagnosis: coolant liquid overheated

Potential cause:

- Coolant liquid in poor condition (boiling point).
- Air inside the coolant circuit, causing corrosion.

Before fitting a new water pump, please carry out the following:

- Change the coolant fluid.
- Bleed coolant circuit

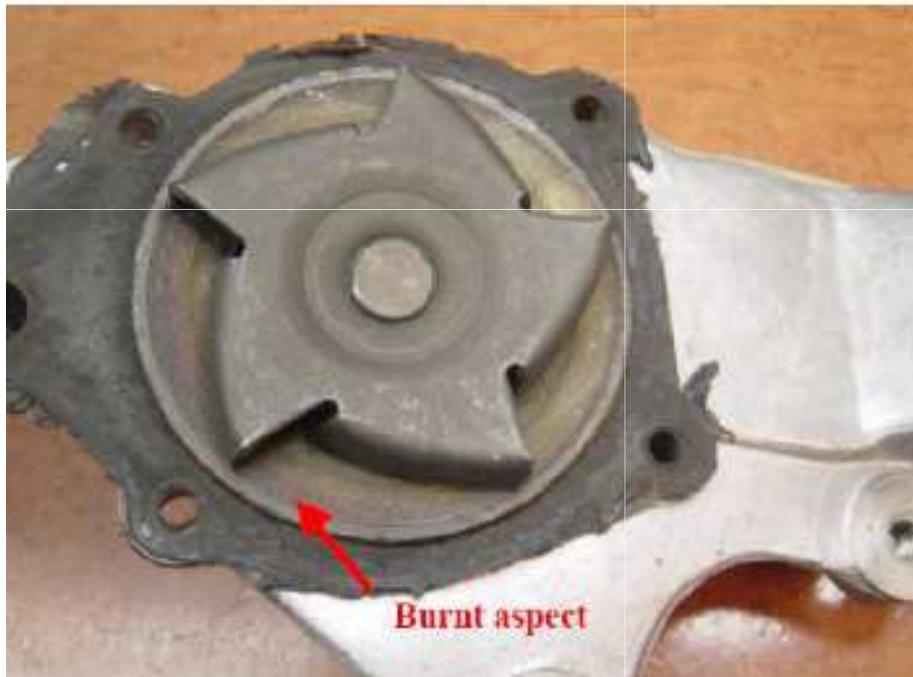
1.4 Burnt aspect

Defect description: leakage on the water pump

Diagnosis: the water pump has a burnt aspect

Potential cause:

- Overheating of coolant circuit
- Blocked coolant circuit.
- Lack of coolant.

Before fitting a new water pump, please carry out the following:

- Change the coolant fluid.
- Bleed coolant circuit
- Only use the correct coolant fluid containing corrosion inhibitor recommended by car manufacturer.
- Check and replace if necessary thermostat and fan switch

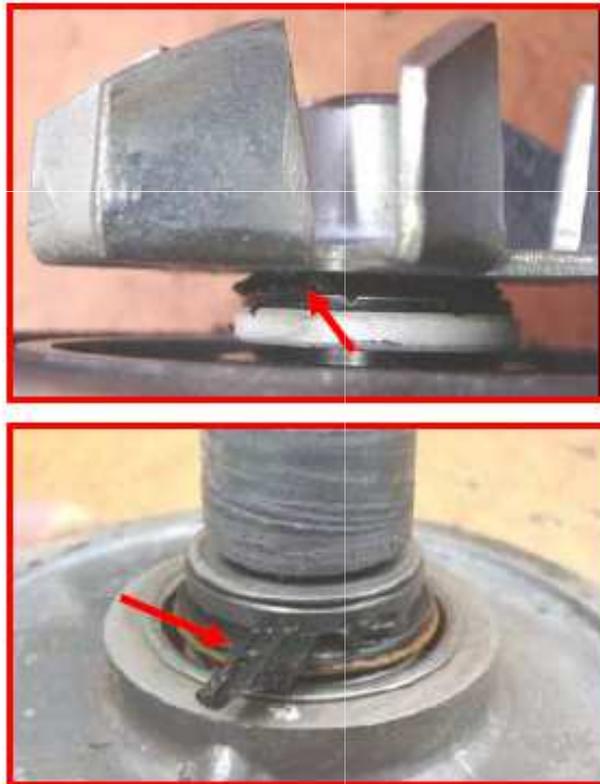
1.5 Sealant paste contamination

Defect description: leakage on the water pump

Diagnosis: contamination by an sealant past excess

Potential cause:

- Application of sealant paste where it is not needed
- Application of excessive amount of sealant

Before fitting a new water pump, please carry out the following:

- Control on the notice if sealant past is necessary
- Apply only a little line of sealant paste

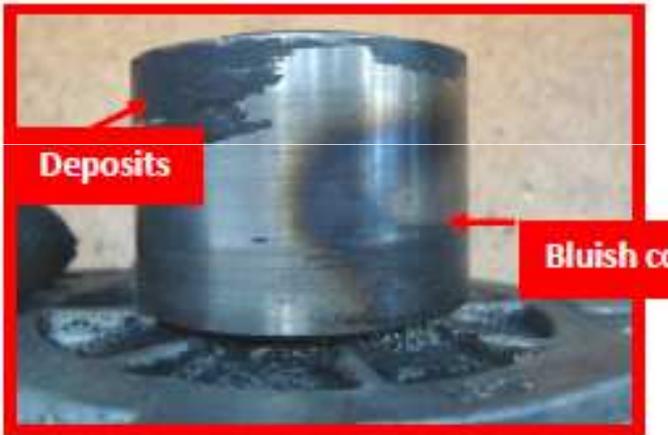
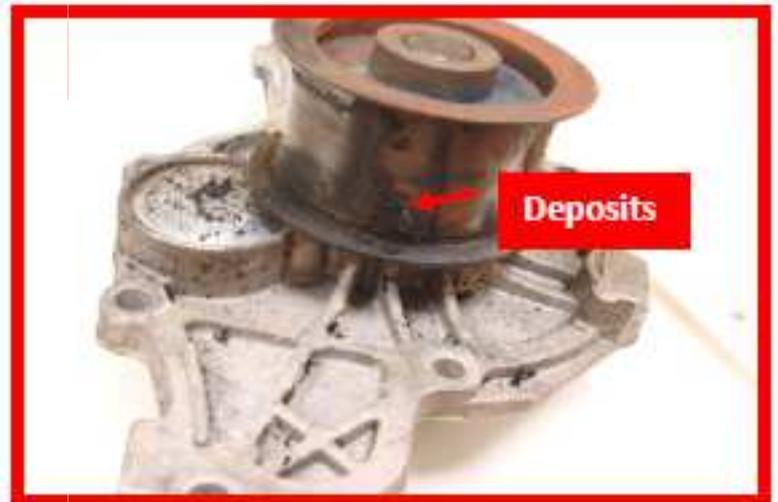
2.1 Bluish colour of the pulley (for models with timing belt)

Defect description: Coolant circuit overheated

Diagnosis: Deposits of belt on the pulley and bluish color of the pulley

Potential cause:

- Excessive tension of the timing belt
- Misalignment of the timing belt

During fitting a new water pump, please carry out the following:

- Replace the timing belt, pulley and tensionner
- Check and replace if necessary thermostat and fan switch

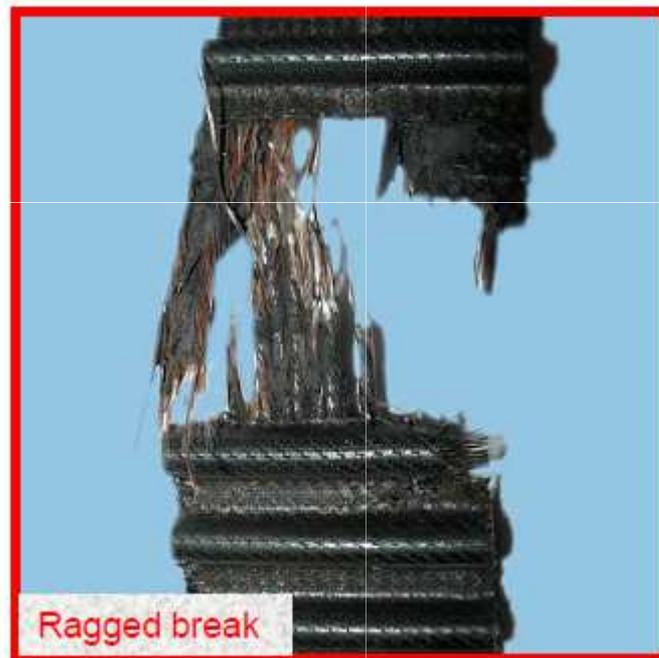
2.2 Ragged broken belt

Defect description: Engine stops

Diagnosis: Ragged broken belt

Potential cause:

- Penetration of foreign matter in the transmission
- Locking of a transmission component
- Excessive assembly tension

Correct belt assembly is required as excessive belt tension has a negative impact on the bearings and may cause premature water pump failure.

Use a timing belt tension test device.

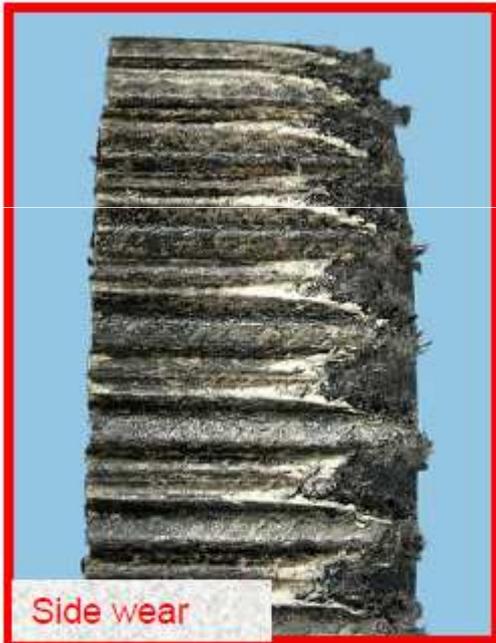
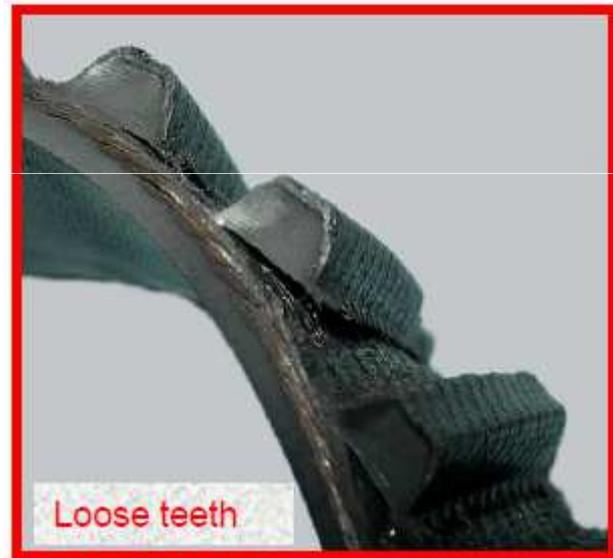
2.3 Belt side wear

Defect description: Engine dysfunction

Diagnosis: Side wear of the belt or loose teeth belt

Potential cause:

- Misalignment of one of the transmission components (tensioner, idler...)
- Low working tension of the belt
- Penetration of foreign matter in the transmission

Correct belt assembly is required as excessive belt tension has a negative impact on the bearings and may cause premature water pump failure.

Use a timing belt tension test device.

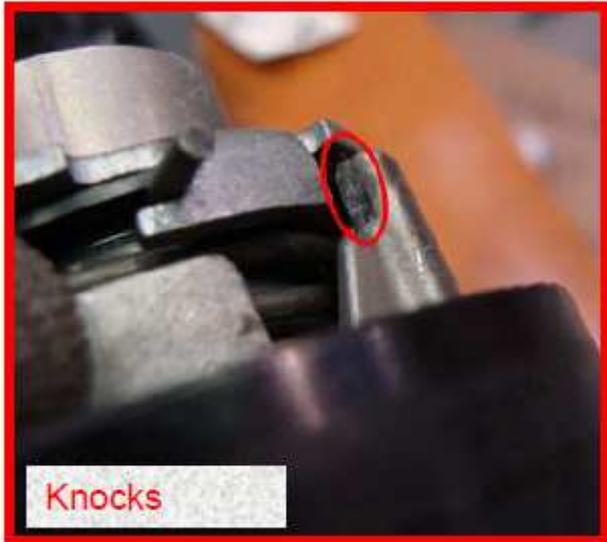
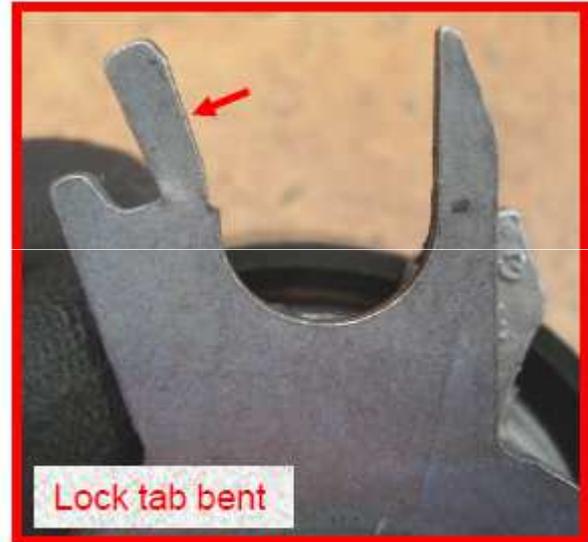
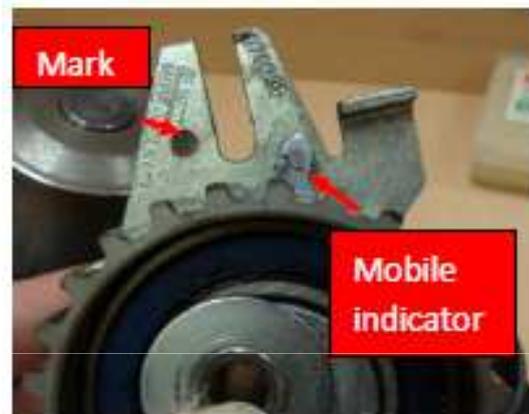
2.4 Knock on the tensioner (VW engine)

Defect description: Engine stops

Diagnosis: Knocks on the tensioner

The mobile indicator must be aligned with the mark

Potential cause:

- Wrong fitting

Control the timing belt notice to ensure respect of fitting instruction.
